More Photographs of the Repairs to G.W. Brake Van, 17953

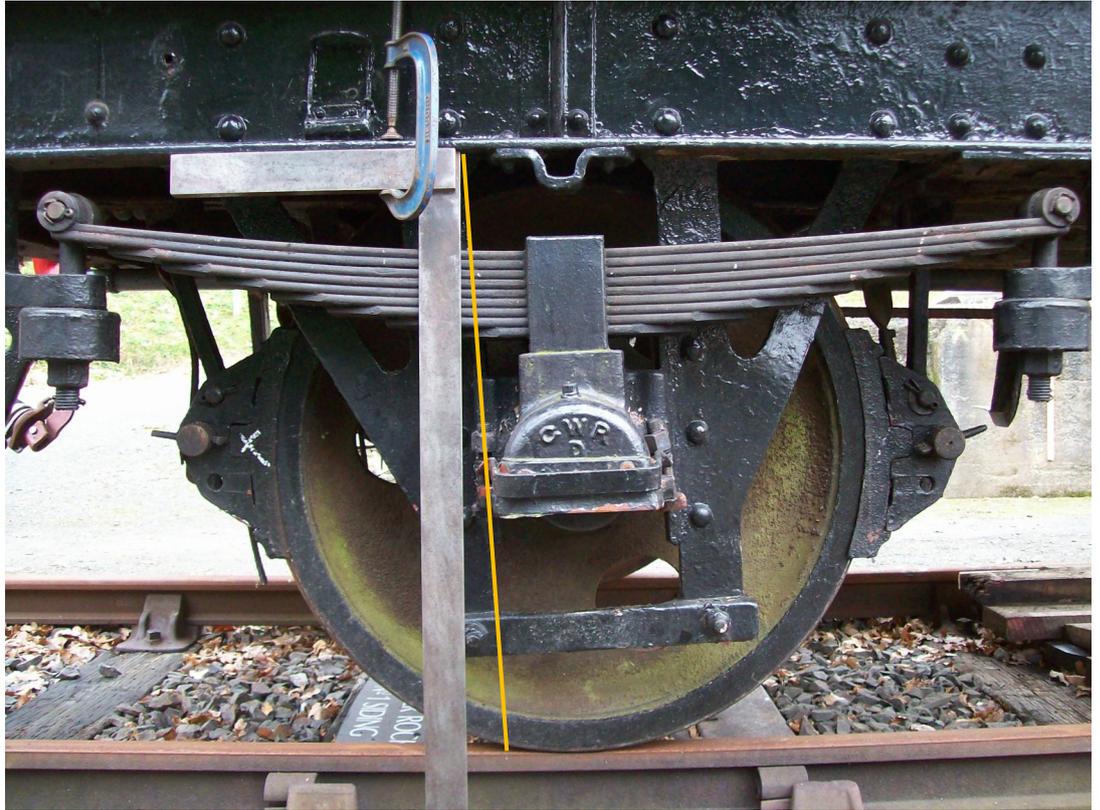
Whatever the van struck, it was enough to fracture the axlebox and bend the axleguards wildly out of true, as indicated by the yellow line.

The upper part of the "split" box was repaired, after a fashion, by the canal railway and a substitute well fitted.

The vehicle would never have been allowed to run on national metals and it is doubtful that it was even allowed to run on the isolated section of the Cambrian at Llyncllys, while it was there.

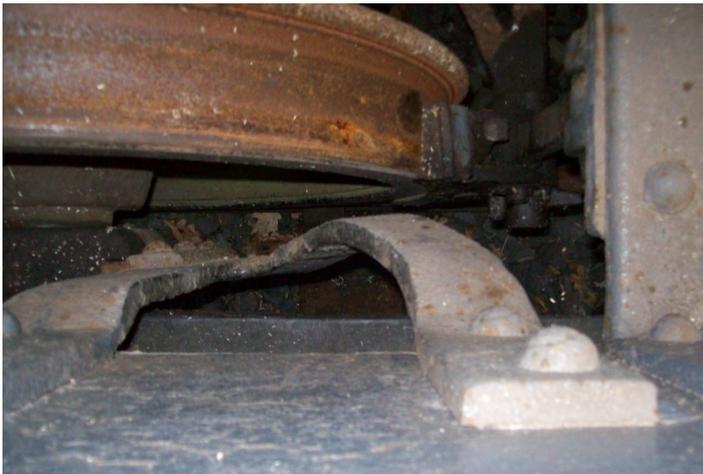
Left: The bent axleguard, seen from above.

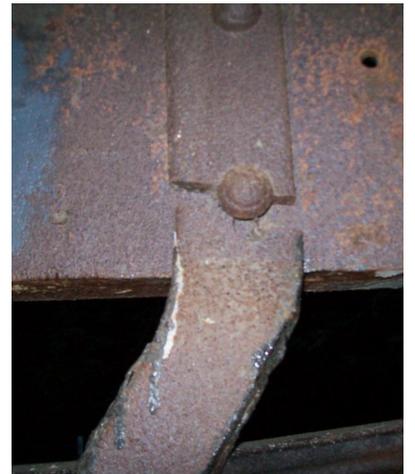
Right: The other one had fractured from a rivet. The same fracture was found on the diagonally opposite side of the vehicle.

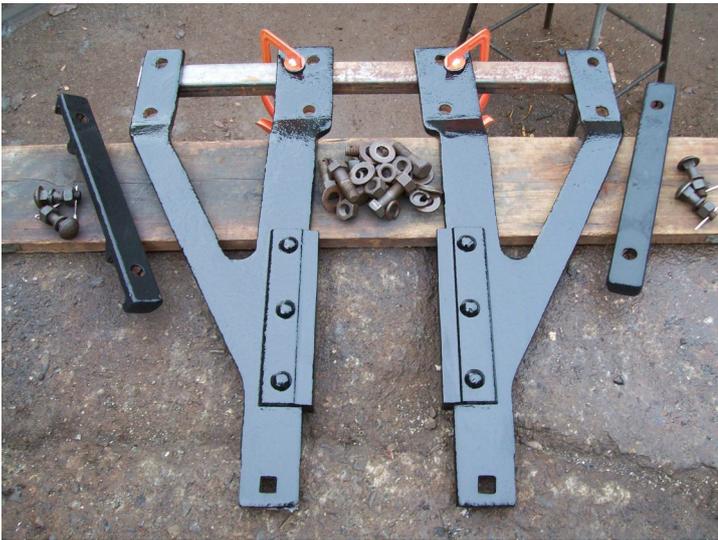
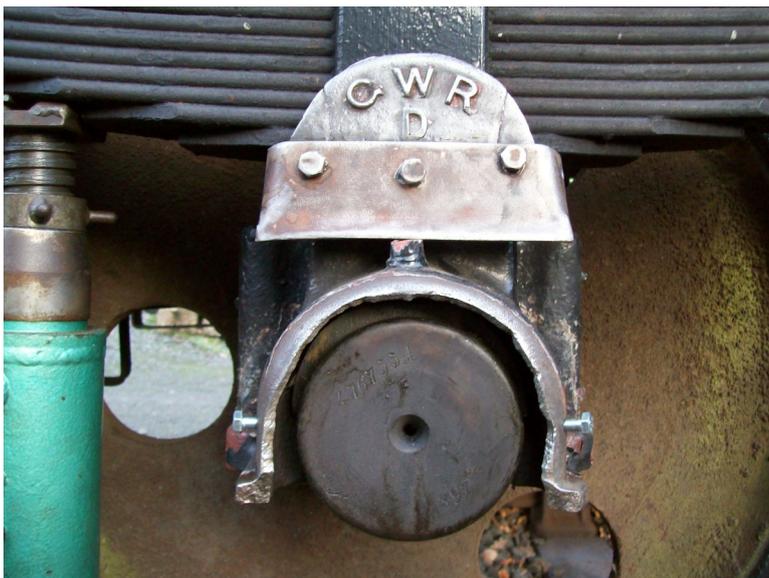
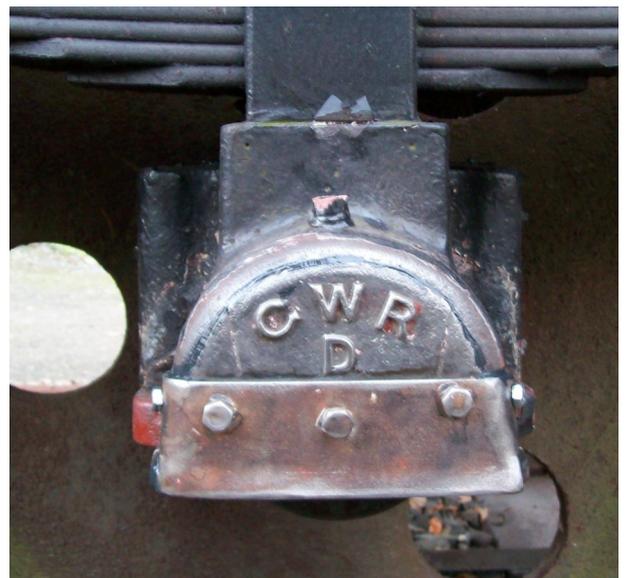
In this condition, the vehicle would not be allowed to run in train formation on any railway.

The fractured part of the axlebox was cleaned and glued, as well as being screwed as seen.

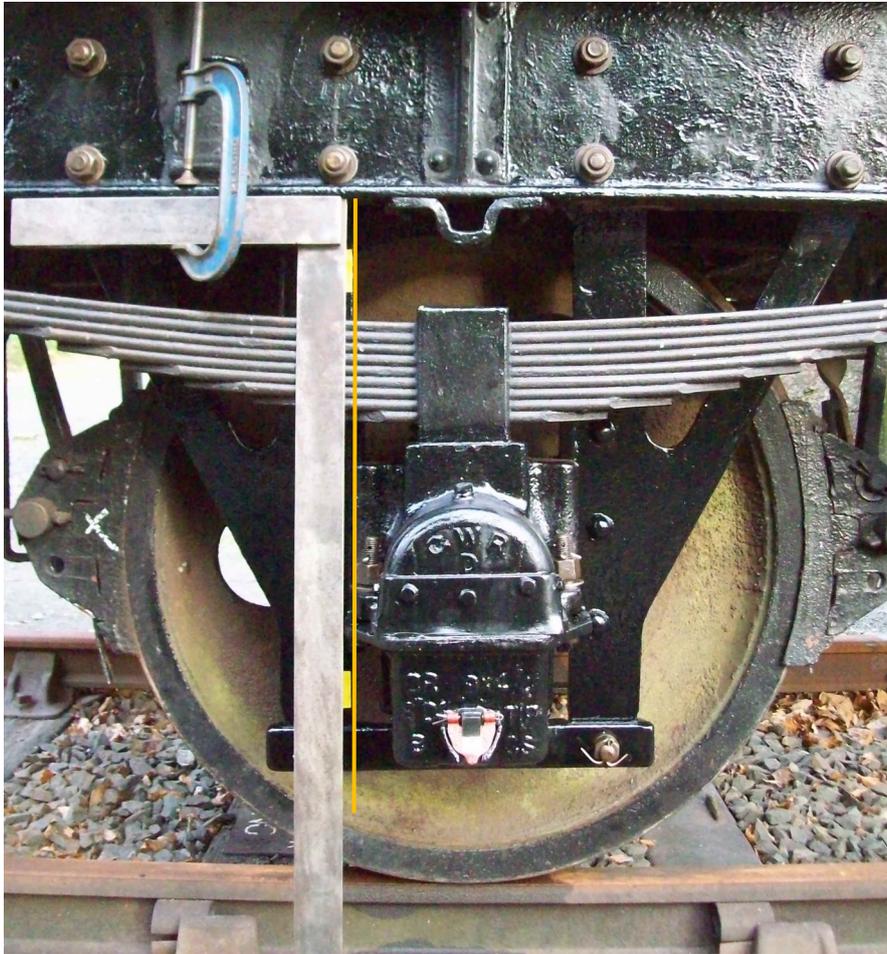
After final assembly, the misalignment was found to be minimal.
The camera lens has distorted the frame and rail.

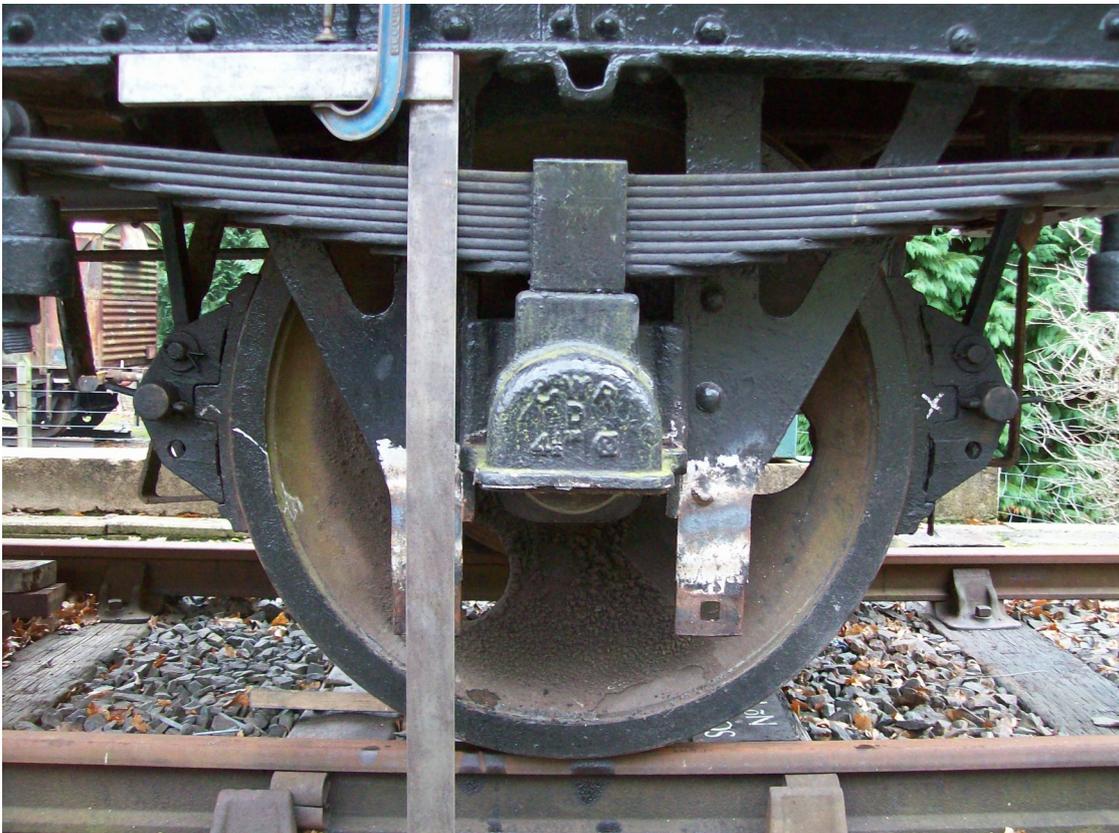
The small misalignment on the opposite side was left alone, except that the lower parts of the axleguards were straightened.

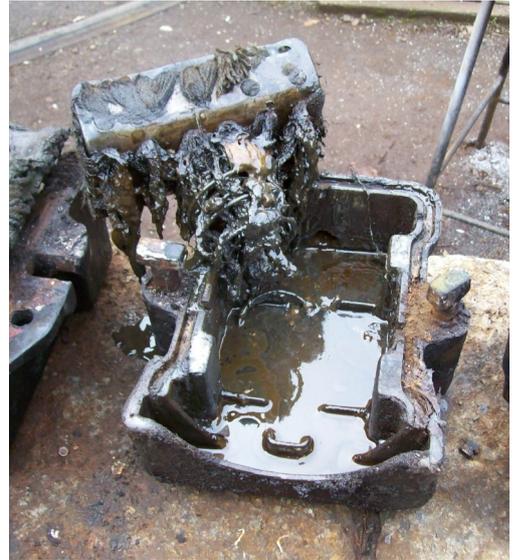
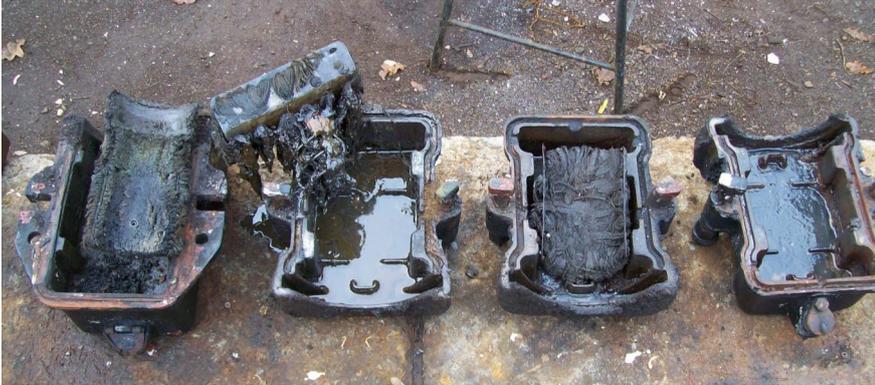
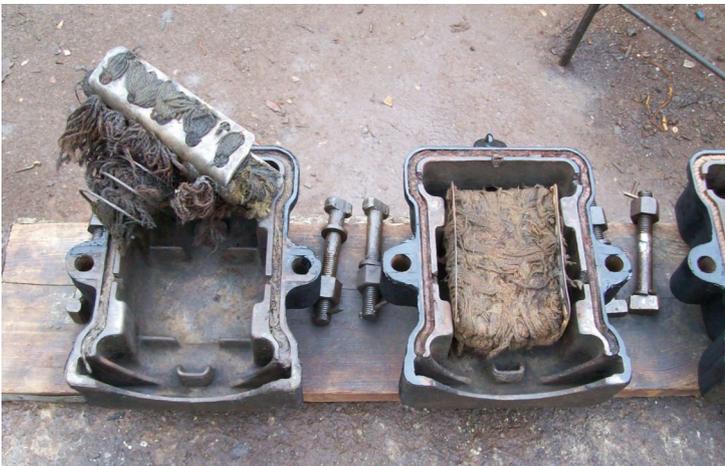
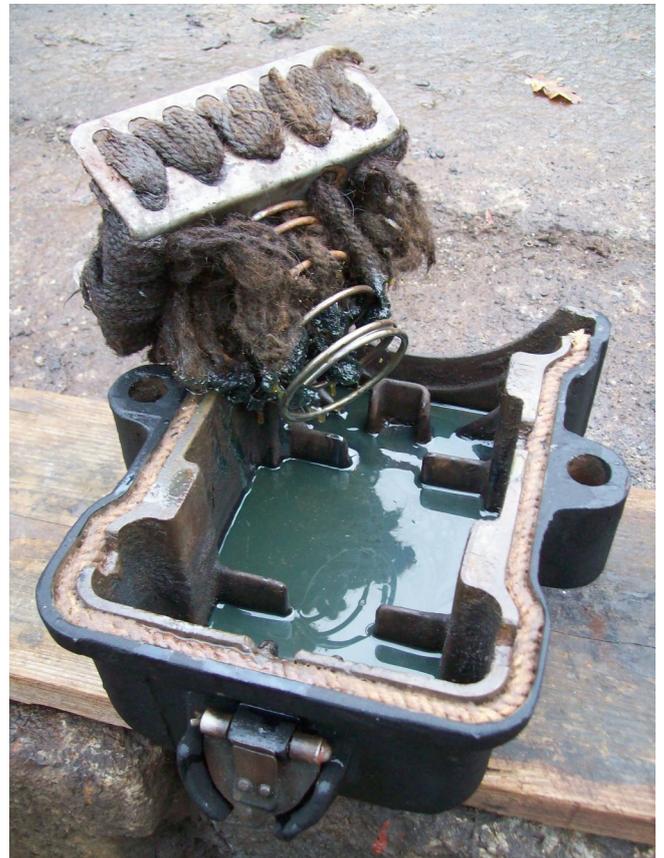
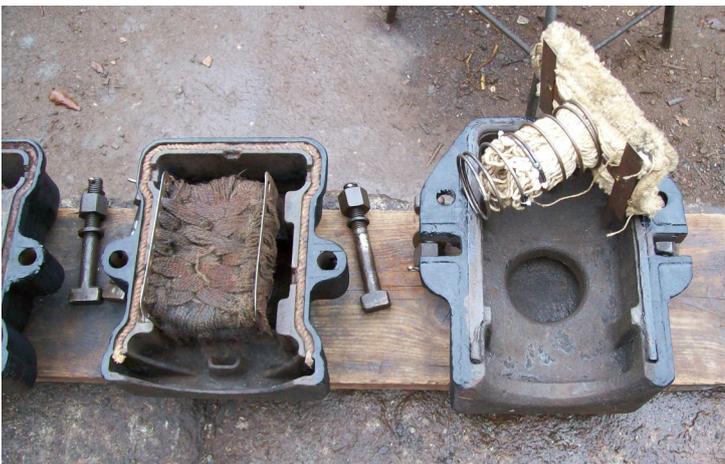
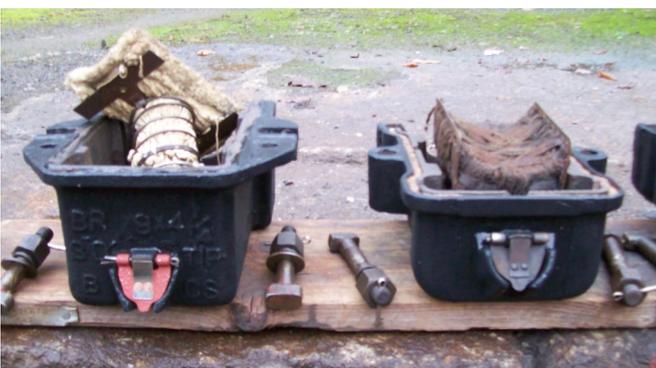
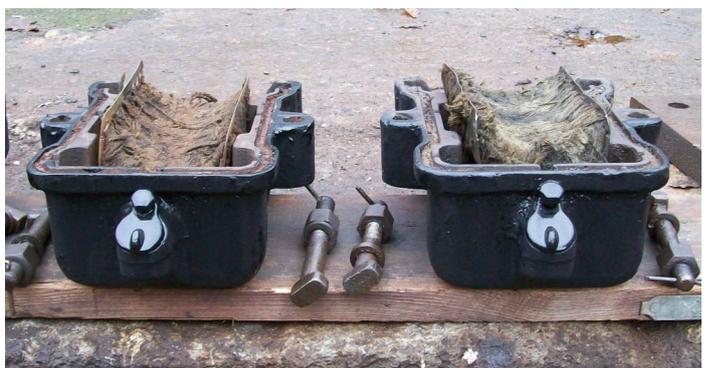
The axlebox wells were full of water and sludge. The pads must not have been inspected or the oil replenished for a great many years.

The wells were thoroughly cleaned and torched. One new oiler pad was provided and the wicks in the three others were cleaned and dried.

New hemp jointing rope was set in Denso paste.

A new stainless steel spring was made for the substituted box, cut from a cheap filling knife.
