## Llangennech and Carmont

### A closer look at two recent mishaps

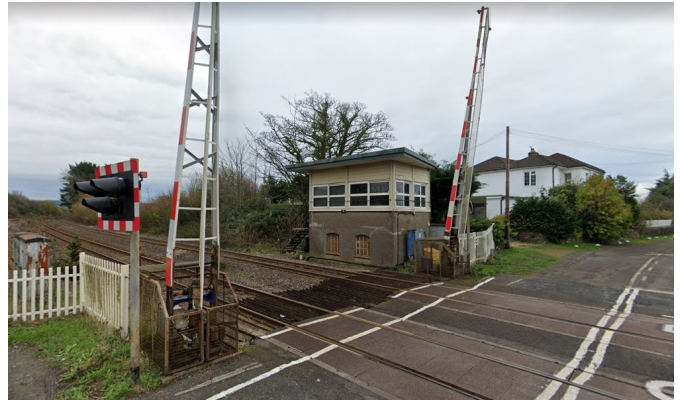
Kidwelly Signal Box.

The signal box at Kidwelly, on the Downside, about 14 miles from the mishap site, controls an adjacent level crossing, which would have been brightly illuminated. Whether the signalman properly observed the train here is perhaps immaterial, because it is not certain that the wagon defect would have been obvious.

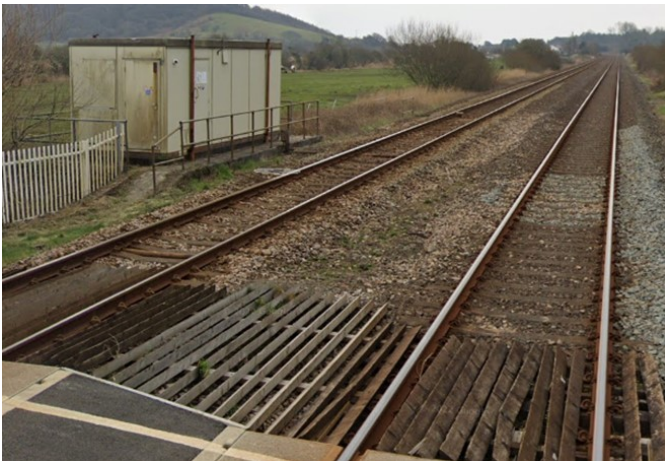
At 2246, two and a half miles further on, the C.C.T.V. camera at Penn-y-bed Automatic Half Barrier Crossing recorded sparking from the wheels of the defective wagon. It is unlikely that a motorist was held at the crossing or that anyone saw the train here.

The camera appears to be fixed to the wall of the cabin at Penn-y-bed Crossing, left.

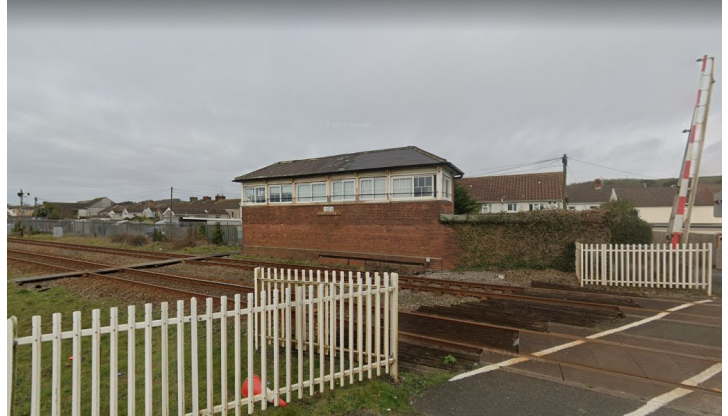
Pembrey (formerly Pembrey East) Signal Box.

Pembrey Box, formerly Pembrey East, lying on the Up side, has lost its large layout with two junctions and now there are only five semaphore levers left in its 83-lever frame. It also controls a level crossing, not brightly lit after dark by the streetlamps on either side.

Signalmen are required by the Absolute Block Signalling Regulations to observe trains as they pass to ensure that they are safe and complete. In order properly to observe the passage of a train, particularly a freight train, the signalman would have to go to the window, preferably sliding it open, the better clearly to see and hear. His job is not that of a Carriage & Wagon Examiner: a signalman can only look out for strikingly obvious wrongs.

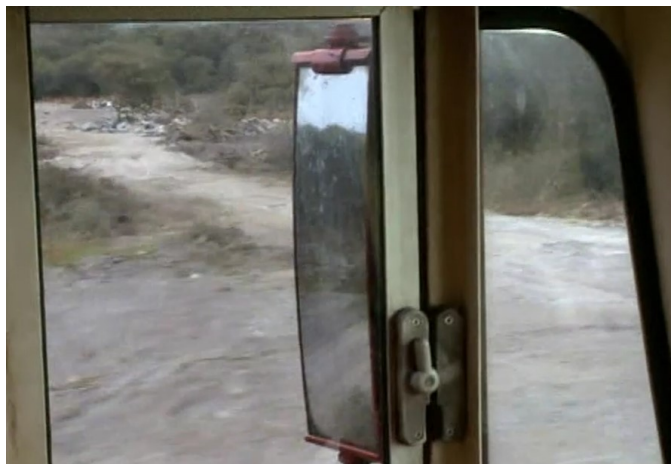
A rear-view mirror of a Class 66 seen from within the cab.

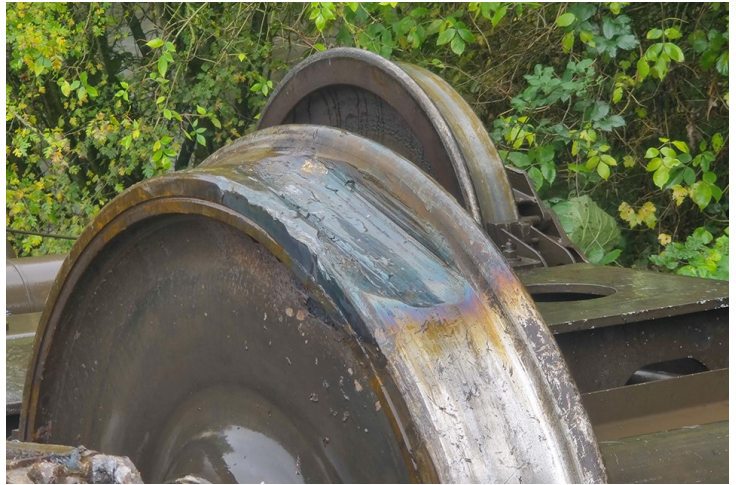
With each wheel imposing nearly 13 tons on the rail, large flats were formed which became a cup profile with a so-called "false flange." This eventually caused the wheels to derail on a trailing crossover situated in rear of the junction.

**Right:** A wheel with a “false flange,” much like the ones found at Morlais Junction. From the R.A.I.B. preliminary investigation into the derailment of a freight train at Patterill Bridge Junction, Carlisle.  
*Crown copyright.*

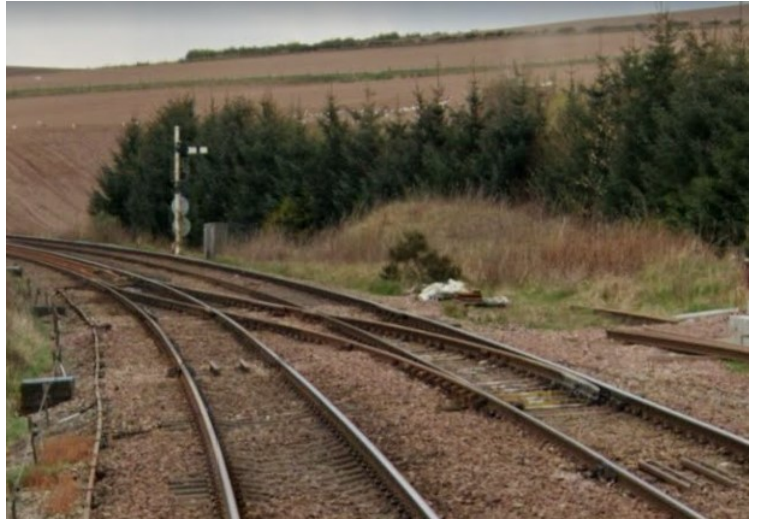
It can be seen from the level crossing that the points of the trailing crossover have no facing point locks. Further, the points on the Down line (right) appear to have no rod connection, suggesting that they are sprung. An instruction stuck to the diagram in the box prohibits the crossover being used from this direction.

There are adjustment switches on either side of the points on each line. These take up movement of the continuously welded rail and avoid any disturbance of the pointwork.

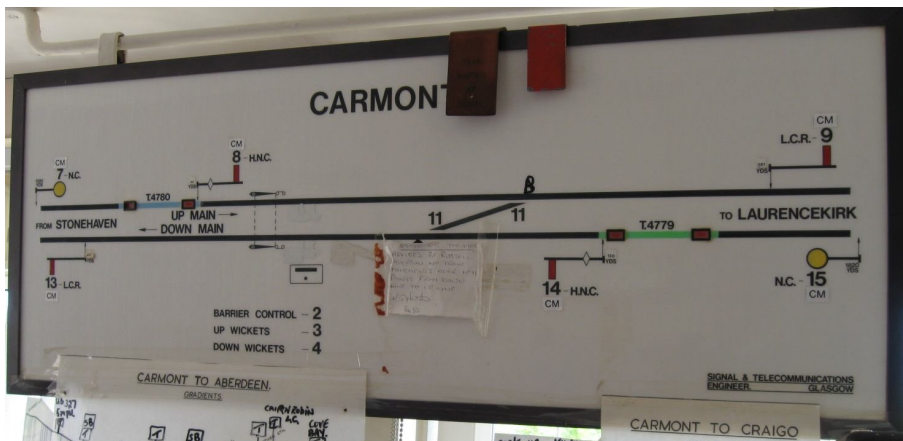
The signal box diagram has an instruction stuck next to No. 11 crossover points.

"Advised by Russell (surname) no train movements over No. 11 points from Down line to Up line."

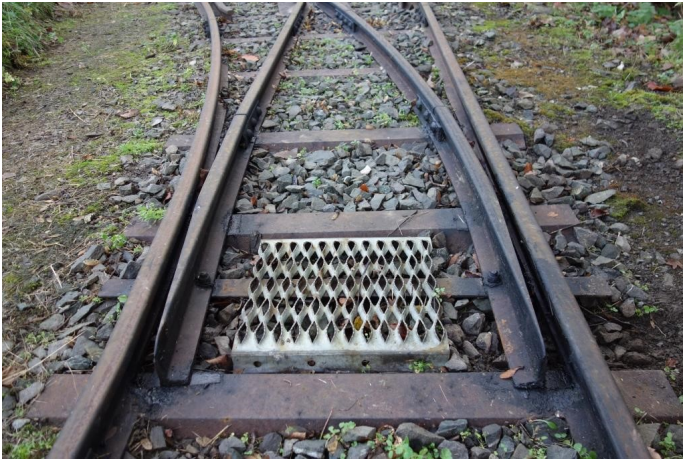
In the simplest form of switch, the point rails are free to move and can be "trailed"—passed through by vehicles coming towards the camera from either direction.

If the point rails moved like this beneath a train travelling in the facing direction, it is possible that following wheels would find their way onto the other line.

The point rails of a narrow gauge switch like this can be kicked over; heavier rails would require a lever.

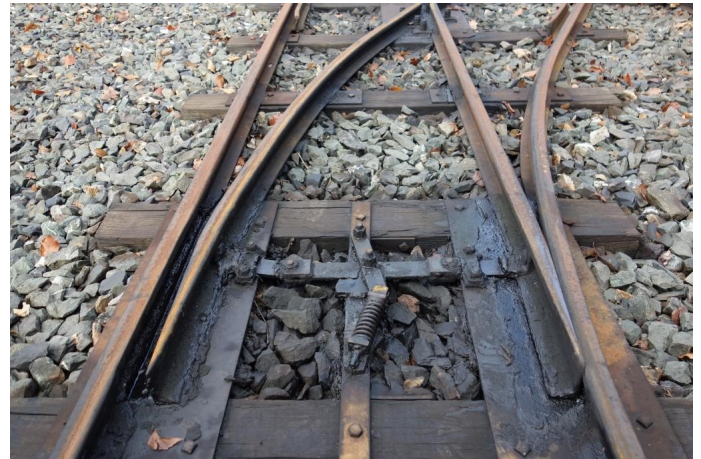
This switch has a sprung mechanism that holds the point rails in one position or the other. The switch can still be trailed from either direction.

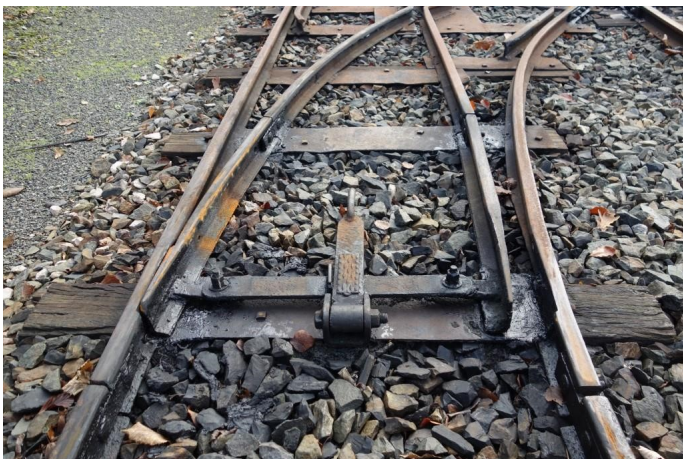
A rudimentary lock ensures that there is no movement of the point rails under traffic. This would derail a vehicle trailing the switch from the wrong direction.

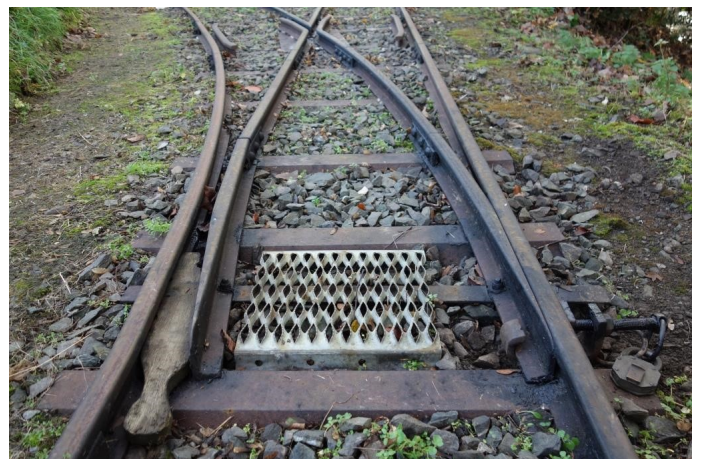
Here the simplest form of switch has been secured, very much like a standard gauge one made of much heavier material.

One point rail is clipped to the stock rail and the other point rail is held away from the stock rail by a scotch. This would derail a vehicle trailing the switch in the wrong direction.

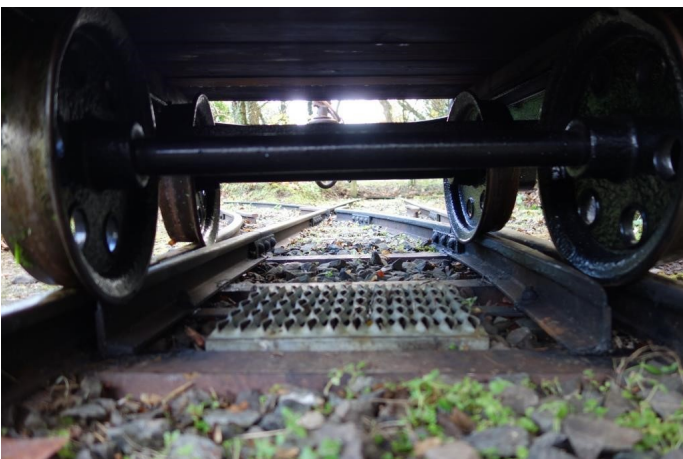
The wagon's wheels have been made to take different courses in a greatly exaggerated demonstration of what may happen in the most unlikely event.

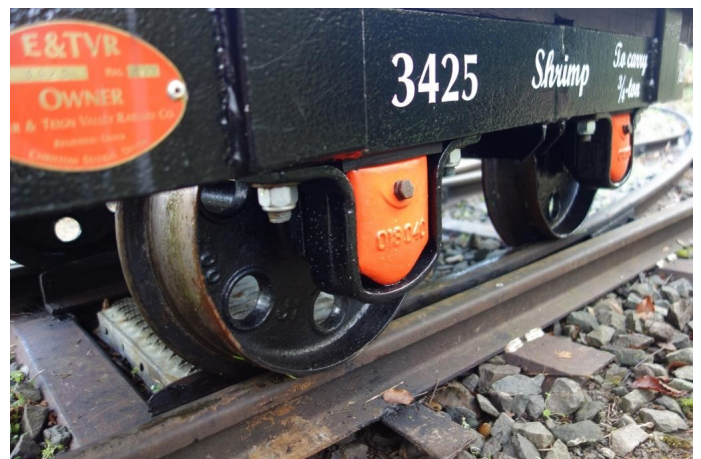
The leading wheels have taken the correct course but the point rails have opened sufficiently for the trailing wheels to have gone the other way. Derailment will follow.
