## Llangennech and Carmont

### A closer look at two recent mishaps

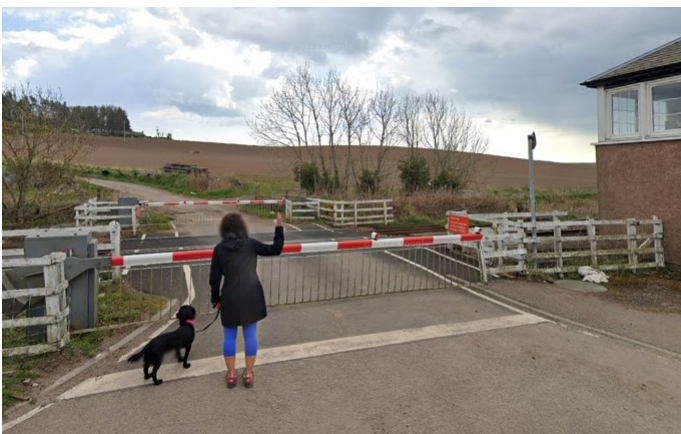
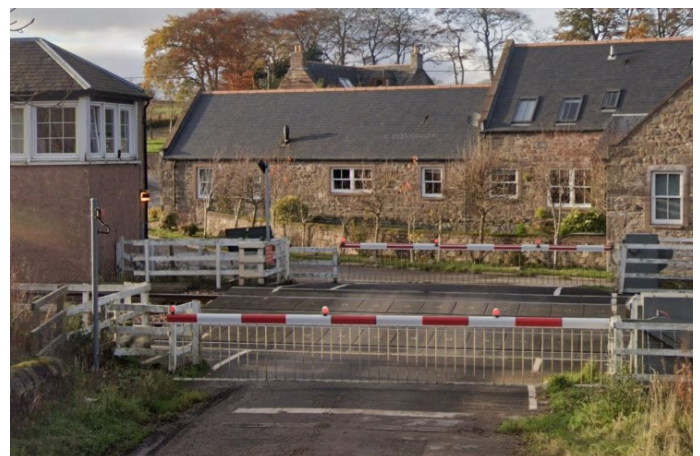
**Left and right:** Carmont operates as level crossings did in the beginning: the barriers are only opened when demanded by a road user, in this case a pedestrian and her dog. There are no wicket gates and no flashing stop lights.

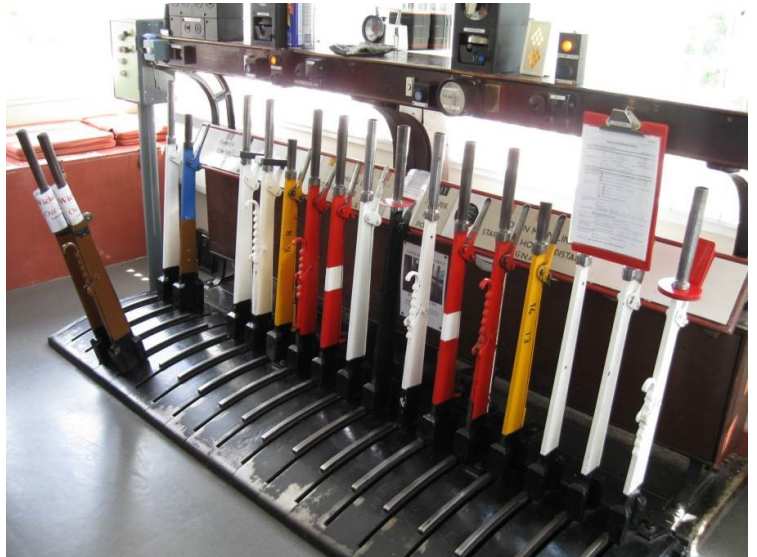
Carmont Signal Box's lever frame could not be much simpler. The yellow levers are the Up and Down colour light distant signals. The red levers are the Up and Down homes. The red and white levers work the starters. The black lever would normally work both switches of the crossover but it appears only to work the Up line points. The brown levers are gate locks, interlocked with the signals. The brown and blue lever is marked "Power Control." Levers with their handles cut short merely act as electrical switches and remind the signalman not to exert any effort. White levers are redundant.
